SAFETY ALERT

Trailer Hoist Failure

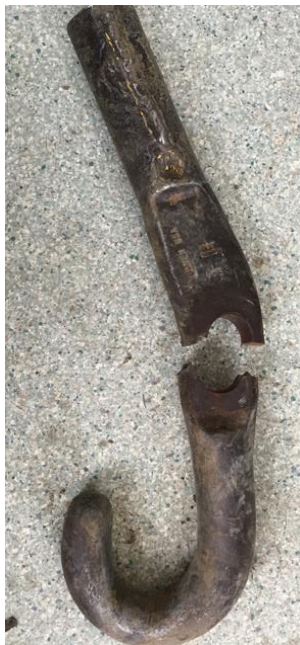
- A log truck driver was lowering the log trailer down onto his truck when the trailer hoist tipping hook failed, breaking in half. The trailer fell approximately three (3) feet. The driver was out of the line of impact and in the designated safe zone. A site supervisor was notified immediately of the incident.

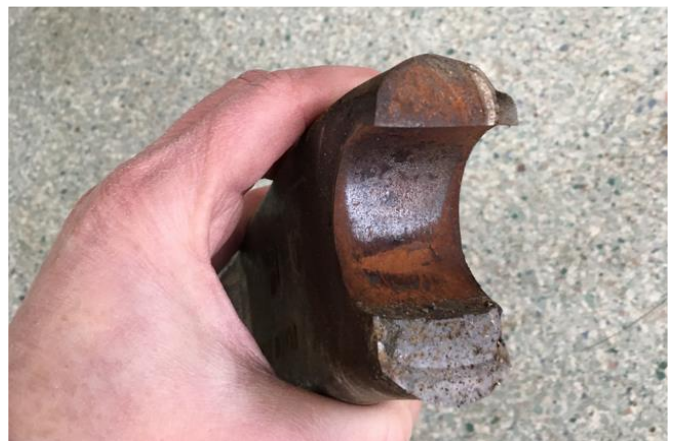
- Previous inspections did not identify the crack that was evident from the corrosion on the cracked area as shown below.

- Complete regular hoist inspections including the tipping hook.
- Ensure thorough inspections for signs of tipping hook cracking.
- Consider incorporating NDT tests into scheduled inspections.
