MANUFACTURING SAFETY ALERT

DESCRIPTION OF EVENT

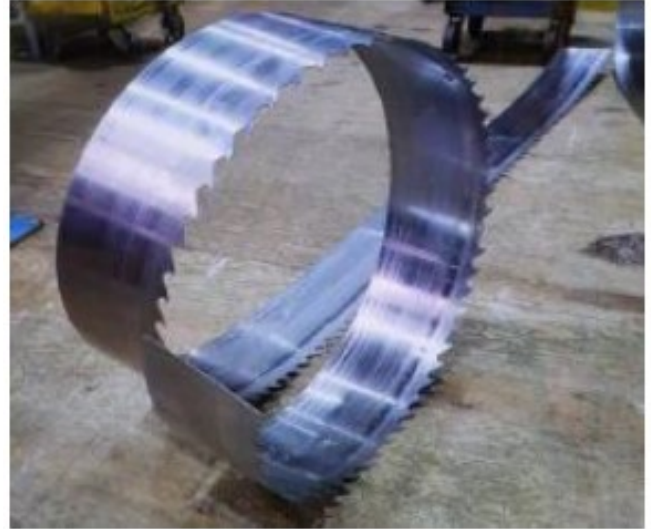
An untrained employee was assisting two other employees to cut saw bands on the shear cutter in the filing room.

When the newly cut end of the saw band got stuck in the shear cutter the untrained employee grabbed the saw band to adjust or un-jam it and caused it to spring up and strike the employee in the face. Intact saw bands form a continuous loop containing a great deal of potential energy. When cut the energy is released causing the band to curl up in the direction of the original loop.

The employee sustained a 3cm long, deep cut above the right eye that resulted in 3 inner stitches and 6 outer stitches.

- Investigate the opportunity to install a hold down bar on infeed of saw band shear cutter.
- Investigate best practices in industry to develop a Safe Work Procedure for cutting saw bands that have been taken out of service.
- Develop an inventory of tasks that are performed within the filing room and ensure that individuals performing or assisting with these tasks are provided instruction on the hazards and safe work procedures.
