MANUFACTURING SAFETY ALERT

DESCRIPTION OF EVENT

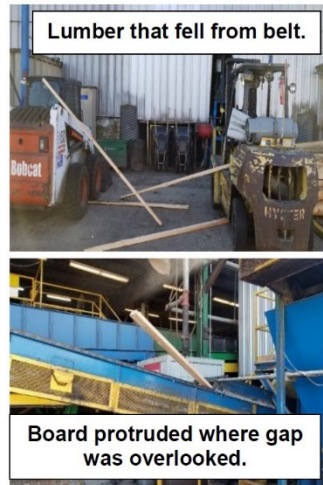
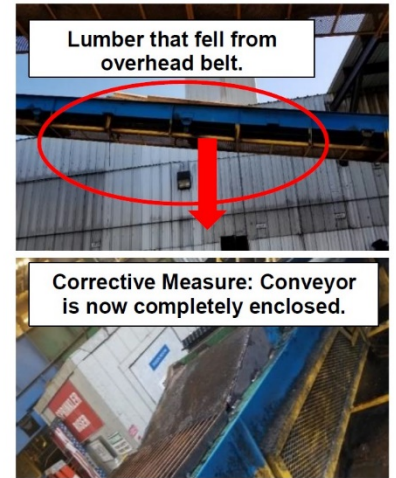
A cross-up occurred on an overhead belt causing boards to fall to the ground below. An employee had completed his forklift pre-trip and just entered his bobcat when this occurred. Guarding was installed to prevent lumber from coming out of the conveyor, but a gap near the transition was overlooked and a board found its way through the gap.

- Ensure conveyor guarding is appropriate and covers all sides, 360 degrees.
- Complete site inspections to ensure there are no similar conveyor deficiencies.
- Complete test runs to verify conveyors are safe and running correctly.

Perform a site audit of all conveyors to ensure that all belts are adequately enclosed and/or guarded to prevent lumber from escaping.
