MANUFACTURING SAFETY ALERT

Safeguarding - Falling Lumber from Conveyor

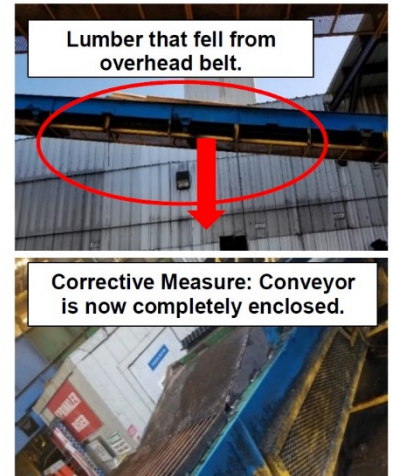
A cross-up occurred on an overhead belt causing boards to fall to the ground from an elevated height.

Guarding was installed to prevent lumber from falling off the conveyor but a gap near the transition was overlooked and a board got through the gap.

- Ensure conveyor guarding is appropriate and covers all sides, 360 degrees.
- Complete a full site inspection to ensure conveyors do not have deficiencies.
- Complete test runs to verify conveyors are safe and running properly.

Perform a site audit of all conveyors to ensure that all belts are adequately enclosed and/or guarded to prevent lumber from escaping.
