SAFETY ALERT

MOSAIC
FOREST MANAGEMENT

SUBJECT: Log/Load Contamination

DATE: March 1, 2022

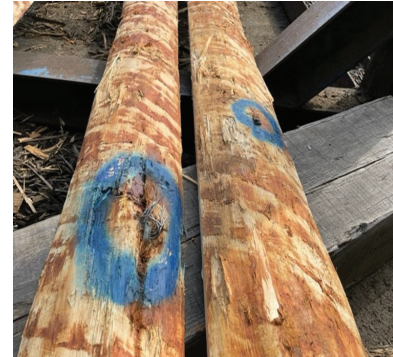
Photo

A log with metal contamination was consumed in a sawmill, resulting in the saw striking the metal. This caused significant saw damage, mill downtime and upset conditions associated with the strike.

- Identify potentially contaminated logs/stands in the planning process so an appropriate plan to mitigate contamination can be made before harvest occurs.
- Ground crew in the field, sort yards and facilities to recognize the potential severity of contaminated loads/logs and diligently identify hazards so they can be removed. Use metal detectors to help identify hazards when warranted.
- When contaminants are found, follow the Contaminated Load Reporting and Follow-up Procedures to prevent further occurrences.
