# SAFETY ALERT

## Challenging conditions, challenging setting for hauling logs

*Ask for assistance when things don't go as planned*

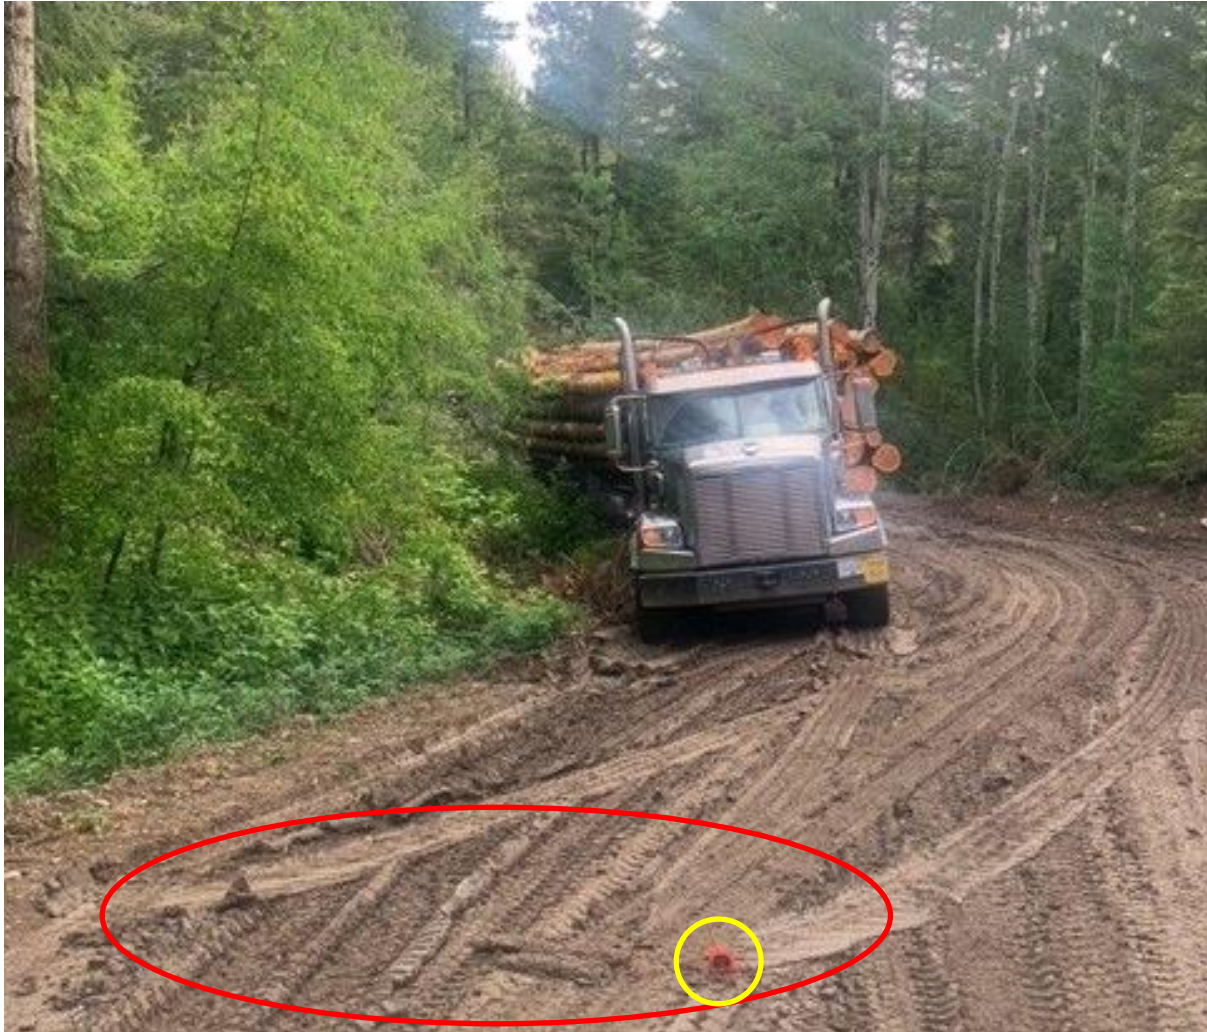
The truck's steering tires travelled forward to the orange tape measure (in yellow circle) then the driver backed up, unfortunately putting him closer to the edge. The tracks show the forward progress of the truck before it ran out of room to manoeuvre.

Drivers should be encouraged to ask for assistance when things don't go as planned. It is better to err on the side of caution. Had the driver immediately requested assistance, he may only have needed a push by a skidder. Ultimately, a loader machine was “walked” in to off-load the logs, reposition the truck and then reload it.

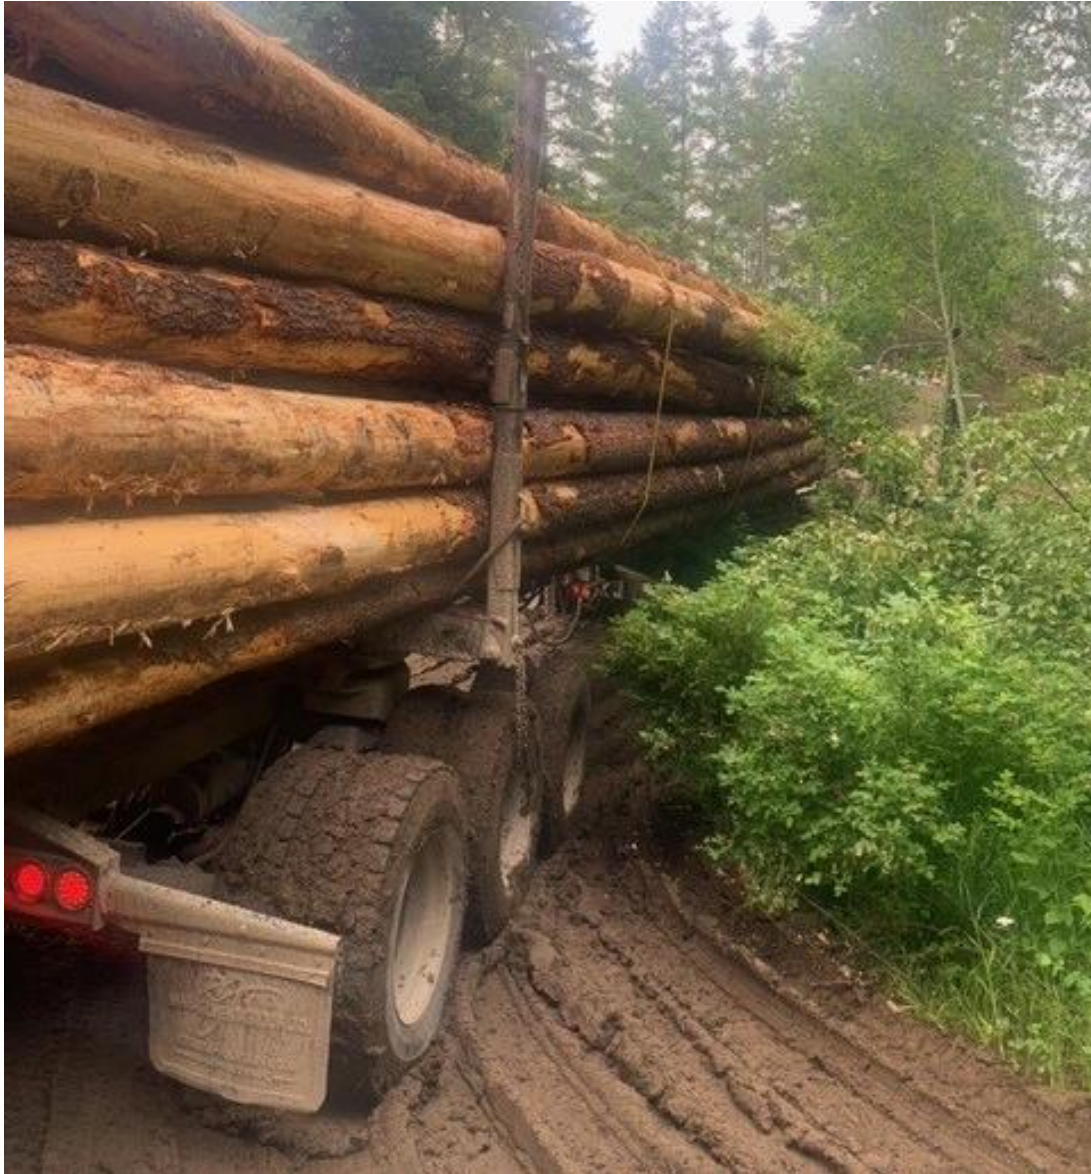
Rear view at the cut corner shows that if workers attempted to pull the truck forward the trailer would clearly leave the road. It's important to recognize an upset condition and be ready to seek assistance.
