MANUFACTURING SAFETY ALERT

Failure to Wear PPE

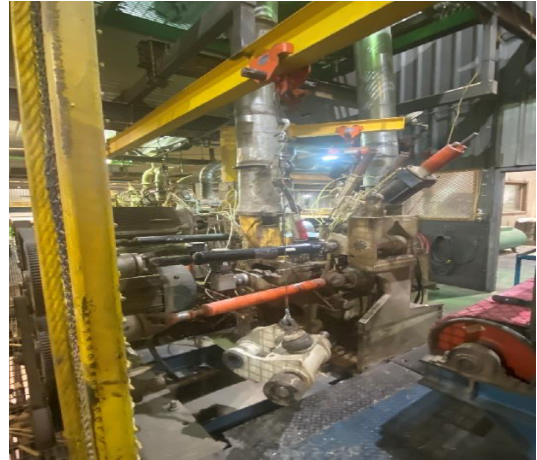
A Planer Millwright was changing a ~200lb Planer Infeed Roll Assembly, due to restricted space they had to change their means of transport and rigging. While lowering the load, using a cable come-along, the locking mechanism failed to reengage allowing the load to free fall, the full force was transferred through the handle which struck the employee on the top of the head.

Because the employee was working in a small space, he didn't wear his hard hat and he suffered a 4cm laceration to the scalp.

- Failure to wear PPE
- Limited anchor points and rigging
- Using a cable come-along for lifting
- Limited workspace
- Failure to inspect tools

Review PPE requirements with all employees and proper use of lifting devices.

- Investigate & trial alternative head protection for tight spaces
- Review PPE requirements with all employees
- Investigate alternative lifting system for the Planer in-feed area
- Review hoisting and rigging procedures with employee
- Review proper use of lifting devices
- Review tool inspections with employee
