SAFETY ALERT

Broken Lift Strap

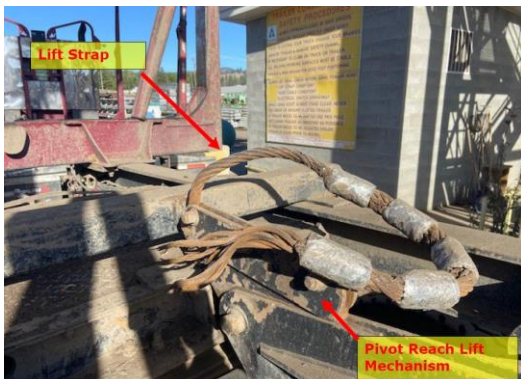
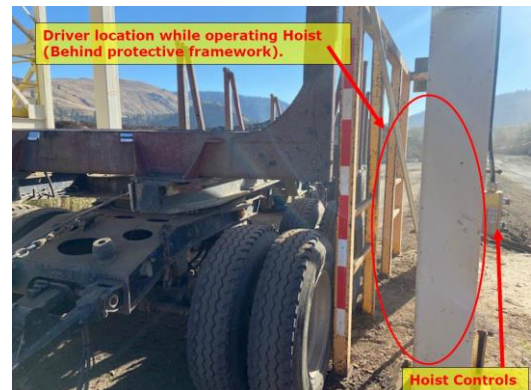
- The incident occurred at the trailer hoist while the truck driver was loading a quad trailer.
- The driver hooked the lift hook to the lift strap and proceeded to lift. As the trailer approached the required loading spot, the trailer fell from the hook.
- The lift strap broke, causing the trailer to fall to the ground. The trailer bounced several times and came to a stop against the safety framework cage.
- The driver was not injured and the trailer was not damaged aside from the lift strap.

- Inadequate inspection and maintenance
- Front lift strap is susceptible to additional wear and tear due to its location

- Ensure pre-trip and post-trip inspection are up to date
- Ensure lift strap is inspected after unloading and before loading trailer
- Visually inspect lift strap condition at both ends of the pivot mechanism
- Lift strap should be replaced if damaged or corroded
- Ensure maintenance records are up to date
