INDUSTRY

SAFETY ALERT

Log Loader Cab Tilt System Fails on Multiple Occasions

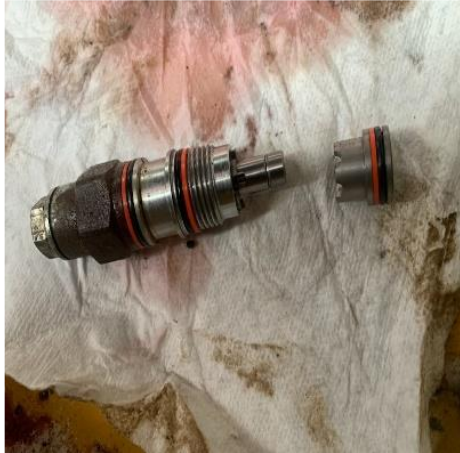
Further investigation revealed that the counterbalance valve was broken which likely was the cause of the original failure. There were 20899 machine hours on this unit.

Failed Counterbalance Valve

- Only trained and qualified individuals should be lowering or raising machine operator cabs.
- Fully inspect all components of the system prior to operating. Pay close attention to cables, pins, mounting points and hoses especially in a system failure event.
- Ensure all fluid levels are optimal
- Ensure that all is clear and nobody - including yourself - is in the bight.
- If any components have been replaced, attach a secondary safety chain in order to prevent unexpected free-falling of the cab. Use it in conjunction with the cab lift system until that system has been fully tested and deemed safe to operate.
- Ensure that all the cab lockdown bolts are replaced and tightened prior to moving and/or full operation of the machine.

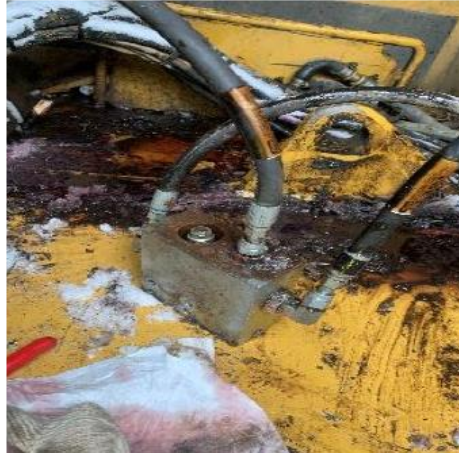
Counterbalance Block

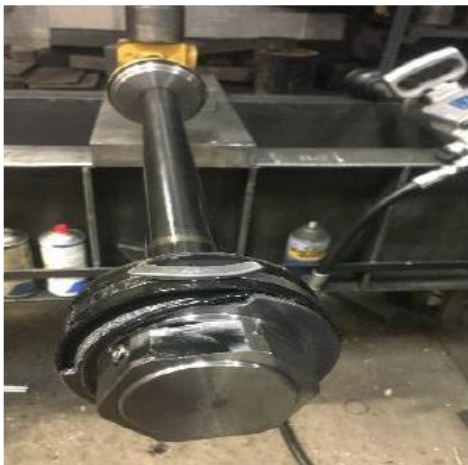
Oct. 24/22: The cab on a Tigercat 875 log loader was being lowered to change the front window and was partially down when it unexpectedly free-fell. The cylinder and emergency cable prevented the cab from hitting the track. However, there was a worker who had walked below the cab just before it fell.

The cylinder was replaced, and the cable had no apparent visible damage.

Initial cab tilt cylinder failure due to counterbalance valve

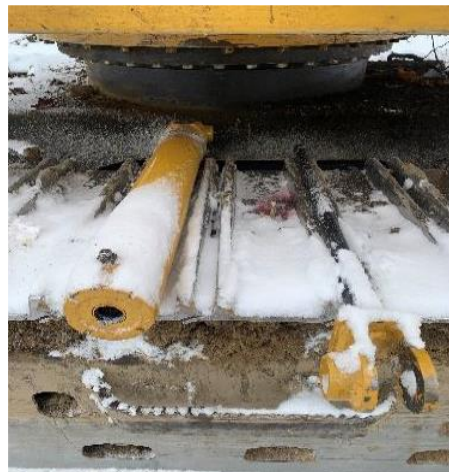
The mechanic moved the cab to the tipping point and back and filled the reservoir to the appropriate level. Satisfied with that result, he moved the cab to the tipping point and again jogged it beyond. The cab unexpectedly free-fell from that position, breaking the cylinder rod *and* emergency cable before coming to rest on the track.

Replaced cab tilt cylinder failure

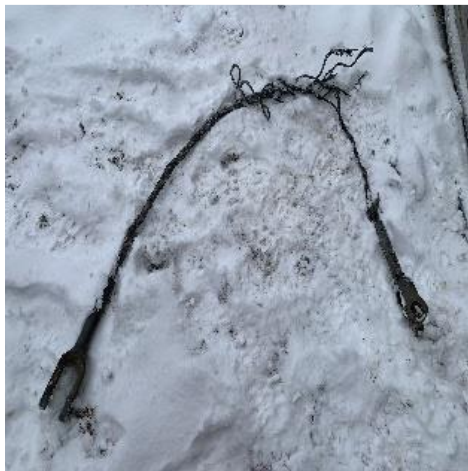
Emergency cable failure after cab free-fall
