MANUFACTURING SAFETY ALERT

Flash Ignition in the Fuel Metering Bin Overflow Hatch

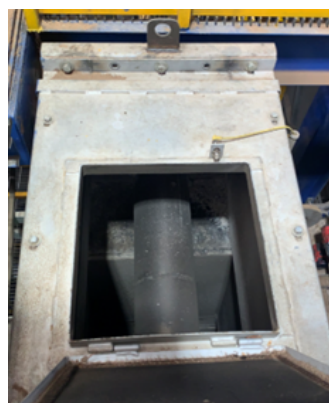
Picture 1 – view into the hatch on day 2 after the furnace burned out

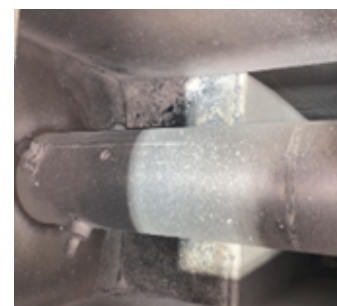
Picture 2 – view onto the ledge on day 2 after the furnace burned out
