MANUFACTURING SAFETY ALERT

DESCRIPTION OF EVENT

Fall from Height

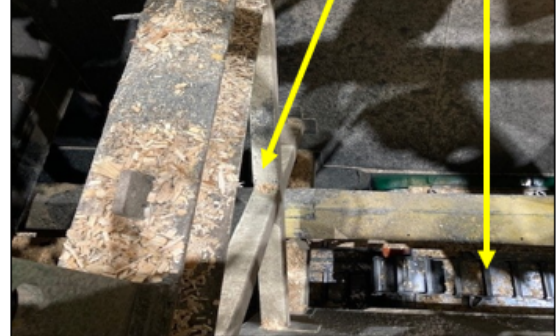
While attempting to climb back out, the worker slipped and fell approximately 6ft into the conveyor injuring the left side of their body on the steel structure. No serious injuries were sustained.

Worker was standing here when they slipped and fell to the conveyor.

- Use hard hat with straps when working at heights.
- Review BC OHSR 8.11 (4): Chin straps or other effective means of retention must be used on safety headgear when workers are climbing or working from a height exceeding 3 m (10 ft), or are exposed to high winds or other conditions that may cause loss of the headgear.
- Provide employees working at heights with additional education and Safe Work Procedure (SWP) training relating to working at heights and appropriate safety controls.

Use hard hat with chin straps when working at heights.

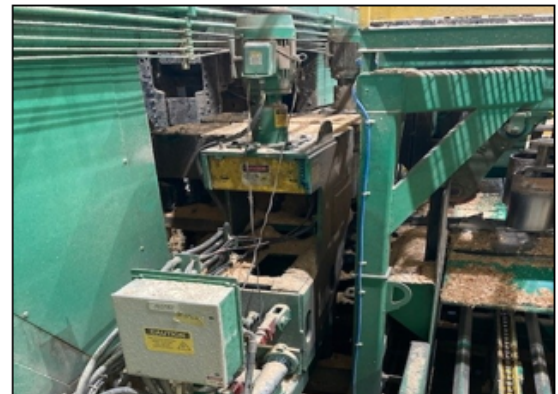
A worker was cleaning the band mill area with compressed air. They were wearing a fall protection harness that was properly tied off with a Self-Retracting Lanyard (SRL).

Worker was performing cleanup during incident.
