MANUFACTURING SAFETY ALERT

Worker Splashed with Hot Water

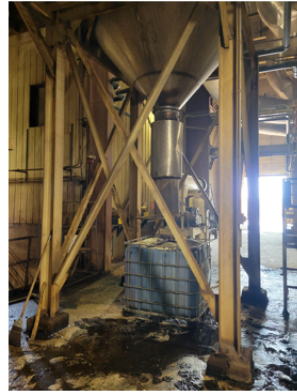
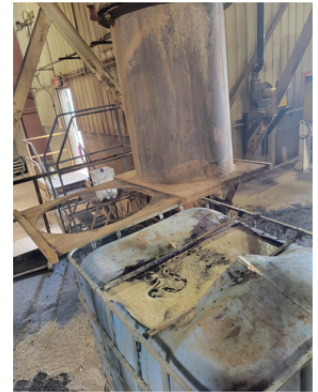
A deluge system activated causing a blend chamber to fill with hot water.

A worker was tasked to open the blend chamber slide gate and empty the hot water from the system. The side gate was plugged with ash preventing drainage. The worker positioned themselves inside the framework of the cone and struck the blend chamber chute with a hammer dislodging the blockage and releasing several 100 gallons of hot water. Due to the worker's location inside of the cone's framework, they were unable to move in time before the flood of hot water soaked them.

The skin on the worker's upper body and forearms became bright red but no significant burns were sustained.

- Review and update procedures emptying residual deluge water from the process system.
- Implement a daily Preventative Maintenance (PM) procedure to open the slide gate to eliminate the chance of ash buildup.
- Review with supervisors and workers the importance of completing a Field-level Hazard Assessment (FLHA) for any non-routine or upset condition tasks
- Consider redesigning the blend chamber area to eliminate potential congestion and provide workers with a safe location to open the side gate.

Consider redesigning the blend chamber area to eliminate congestion and provide workers with a safe location to open the side gate.
