# SAFETY ALERT

## Shock mount failure leaves UTV inoperable

**Date:** September 2023

**Location:** Okanagan region

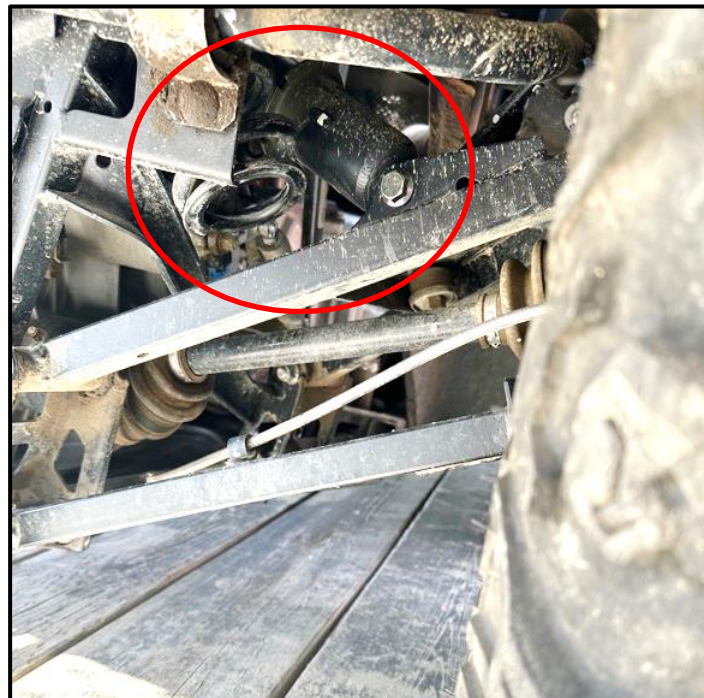
**Details:** A worker was driving a UTV on a deactivated resource road and crossed a cross ditch at low speed when the rear upper shock mount gave way. The shock collapsed on the airbox and exhaust system, damaging both simultaneously. This left the vehicle inoperable and its driver stranded. The UTV rental company was immediately contacted. It was noted that this was the third time that an upper right rear shock mounting bracket has failed. So far, the manufacturer has not confirmed that this is a known manufacturing defect.

**Learnings & Suggestions:** Maintain inspections and mechanical servicing intervals, which might reveal a hidden or pending issue.

Also contact the manufacturer to check if any service bulletins have been published.
