MANUFACTURING SAFETY ALERT

Lock Out Save

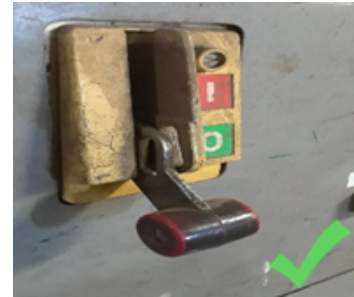
A new worker performed a verified lockout in an MCC room. A cable was used to lockout the main and the 3 separate disconnects.

When the verifier performed the test with the worker, the in-feed chains which was one of the separate disconnects started up.

The disconnect was tagged and when the worker locked out the local disconnect, outside the MCC room, for the equipment, the test passed. The equipment did not start up.

1. Tag out disconnect as faulty and lock out at the local disconnect outside the MCC room.
2. Develop an education/training document to add to the lock out program for educating workers about the Click or Snap that must be noticed to release the knives in electrical disconnects.
3. Perform an inspection of all lock out handles for the site to identify worn out or faulty disconnects.
4. Review the current electrical preventative maintenance MCC work order process to ensure that checks for faulty buckets are included.

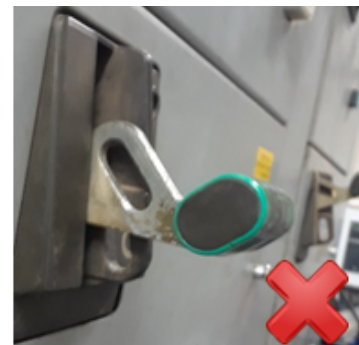
An investigation was performed with the MCC bucket removed and it was perceived to work fine. Upon further investigation it was noticed that if the handle was pulled down slowly, there was a "dead spot" where the handle would seem to stay down even though the knives were not yet released. (Picture 2)
