MANUFACTURING SAFETY ALERT

Near Miss Log Dump Incident

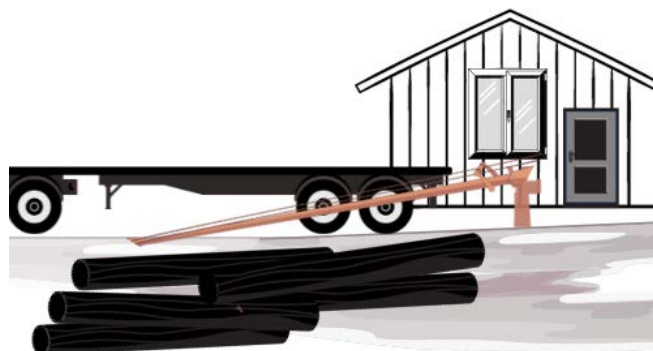
A loaded truck arrived late at the log dump. The crane operator returned to work to dump the long load. Due to low water levels, the worker lifted and swung the load instead of dropping directly into the water. The crane failed and the crane mast dropped and clipped the back of the rear trailer.

During the spring, an annual inspection of the crane of was successful. In that, the crane was certified for operation. During the incident investigation, broken wire rope strands were found within two of the wedge ferrules located at the base of the back guys (obstructed from view).

The investigation determined that swinging the load in combination with the broken guy wires may have caused the crane to fail.

- Ensure that required maintenance inspections and certifications are effectively and appropriately conducted to ensure the safe operation of the equipment.
- Consider increasing the crane's safety factor by increasing the diameter the back guy wires and/or increasing the number of back guys.
- Consider modifying the back guy wire anchor connections to allow for easier inspection.
- Ensure that operators are trained in safe operation of the equipment and that safety observations are carried out to confirm safe performance.
- Ensure comprehensive hazard zones and associated processes to keep workers clear of overhead risks, and that safety observations confirm workers follow established safe work procedures.

Ensure annual inspections are performed on all critical safety related controls, equipment, and wires.

Ensure the crane inspector reviews this incident and ensures that future inspections are adequate to prevent reoccurrence. Where close observation is not practicable at the time of inspection, ensure that operation management is aware of this limitation and provide a plan for inspection when practicable.
