MANUFACTURING SAFETY ALERT

Near Miss – Lockout

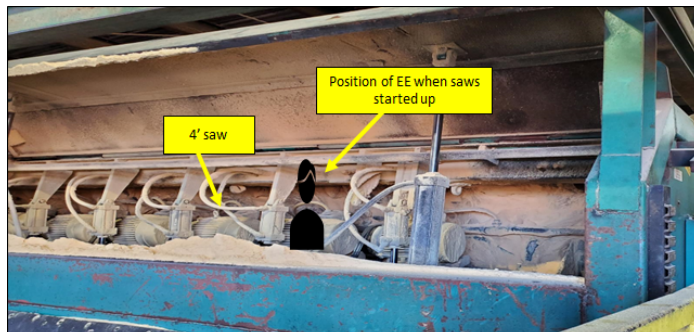
An employee entered a trimmer saw box to replace a four foot (4') saw belt.

Prior to entering, they attempted to lockout. However, they did not complete the “test” portion of the lockout, nor did they have the lockout verified prior to entering.

Two saws that were not locked out properly started up while the employee was still in the saw box.

No injuries occurred.

Review the incident with all employees and explain the importance of testing all lockouts prior to entering into the bite.

- Review the incident with all employees and explain the importance of testing all lockout procedures prior to entering into the bite.
- Review pre-start up inspection expectations with employees.
- Replace control buttons with key control buttons (keys can be placed in lock box).
