# MANUFACTURING SAFETY ALERT

### Serious Incident - Skidoo Incident

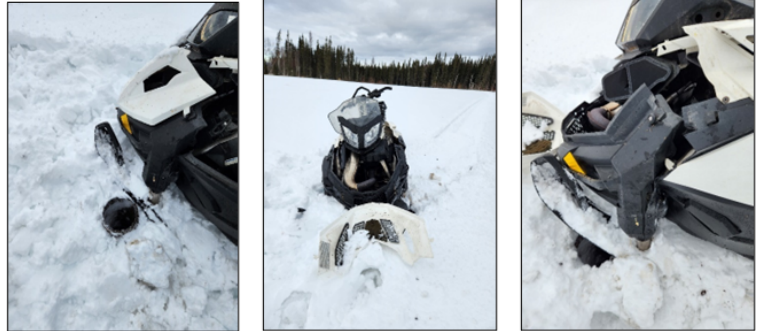
An employee was operating a snowmobile to access a cutblock to perform a check on pile burning. The access roads to these cutblocks had been reclaimed so the roads are inaccessible. The employee decided to avoid the reclaimed roads and take a route through what appeared to be a clear well site.

The employee was travelling at a speed of approximately 40 km/hr. when they hit the first of three pilings hidden under fresh snow. This caused the employee to be thrown from the skidoo and extensive damage to the machine.

The employee sustained no injuries.

- Whenever possible, eliminate accessing drilling sites as a route due to the possibility of hidden hazards such as abandoned well heads or pilings.
- Communicate with oilfield companies before accessing the area to get maps etc. of the layout.
- Revise the Safe Operating Procedure to add in hazards associated with well sites.
- Communicate and train all required employees on the new work procedure and process before accessing a well site.

Revise the Safe Operating Procedure to add in hazards associated with well sites.
