MANUFACTURING SAFETY ALERT

Forklift/Pulp Trailer

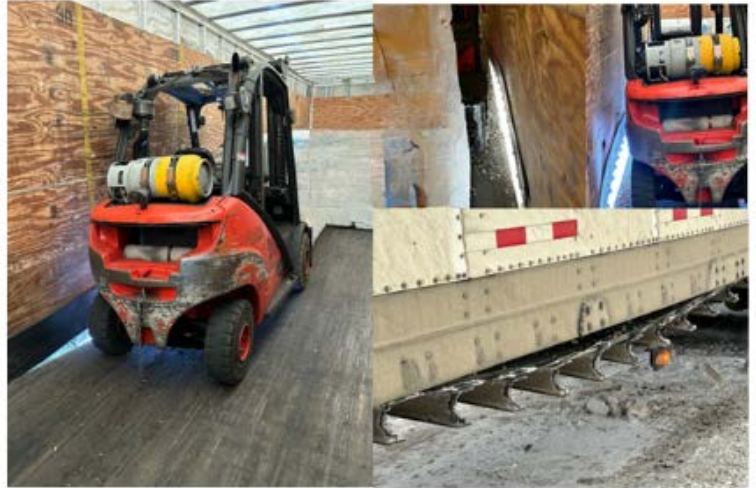
A forklift driver was driving into truck trailer to load pulp units into the trailer. The felt floor on the fifth unit gave way under the weight of the forklift and its load (picture to left).

The supervisor requested assistance to safely remove the forklift and all units from the trailer. An I-beam was used to support the weak spot in the trailer to aid in removing the forklift and the pulp load. A long chain attached to a forklift was also used to pull out the units of pulp.

- Collect daily inspection and Commercial Vehicle Safety and Enforcement (CVSE) Inspection Reports for trucks on site.
- Keep a file of annual CVSE Inspection Reports for all trucking companies.

Review daily inspection and CVSE Inspection Reports for trucks on site.
