# MANUFACTURING SAFETY ALERT

### Failed Electrical Connection

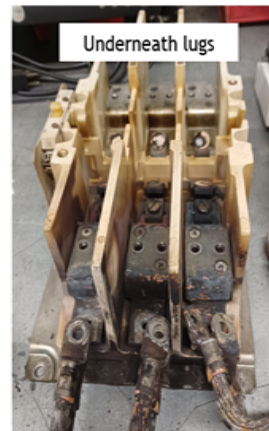
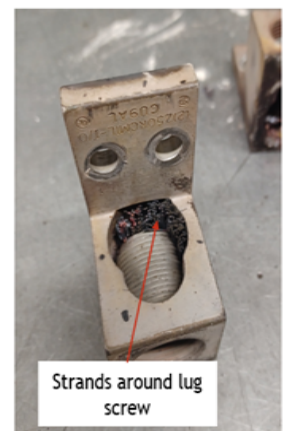
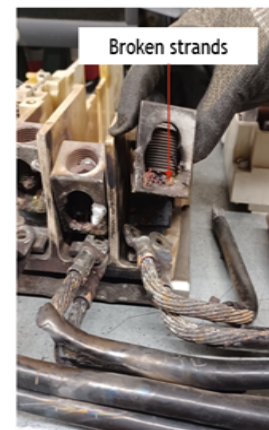
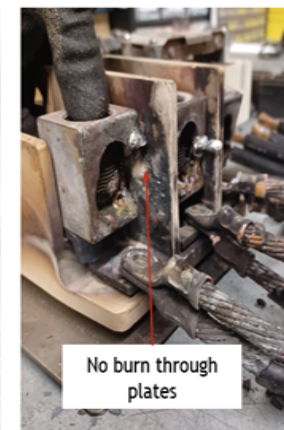
After undergoing routine maintenance on an air compressor, the unit was restarted. When it started back up, the green electrical cabinet suddenly blew open and a bright flash and small explosion occurred.

The electrical lead hand and shift electrician immediately inspected the unit and discovered the cable lugs on the air compressor had melted. A post-inspection found the fuses were still intact.

- Inspect all the cabinets mill-wide to make sure they are properly sealed.
- Communicate the incident to all employees to keep them informed.
- Distribute proper safety procedures to all electricians regarding the use of proper torque rating, lug size, and bolt placement when repairing cabinets.
- Create work orders to consistently use infrared cameras on all cabinets in the future.
- Order and post signs to remind all electricians to follow procedures and ensure all bolts are sealed properly.

Ensure regularly planned thermal imaging of electrical equipment occurs and the electricians understand and comply with proper torque rating, lug size and bolt placement when repairing cabinets.
