MANUFACTURING SAFETY ALERT

Forklift Hand Crush Incident

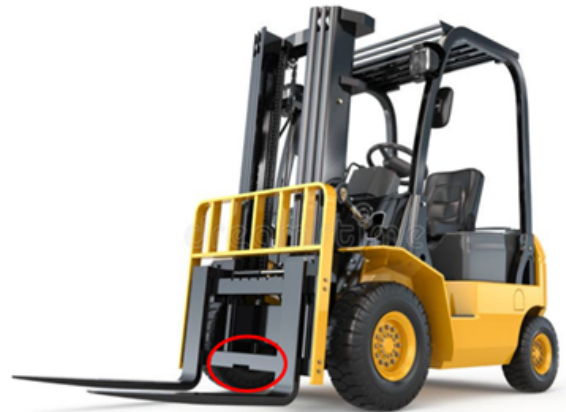
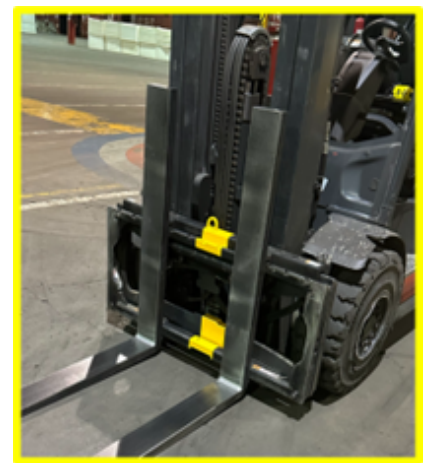
An employee was seriously injured when the left fork of a forklift was repositioned too close to the centre of the carriage.

The incident occurred when a bailerman adjusted the left fork on the carriage of his forklift to accommodate a narrower bale. After collecting the bale, they drove towards the re-pulper and noticed the left fork was askew. They stopped and lowered the bale to the ground then backed up to remove it from the forks. The bailerman then raised the forks correct the misalignment but the machine was leaning towards the fork and it fell from the carriage and struck the employee's hand.

- Consider painting ‘a no fork zone’ with yellow paint around the gap in the centre of the carriage where the fork is removed from the mast.
- Inform employees on incident and forklift safety.
- Install stoppers on outside of forklift carriages.

Consider painting ‘a no fork zone’ with yellow paint around the gap in the centre of the carriage where the fork is removed from the mast.
