# SAFETY ALERT

## Boulder in log bundle discovered during unloading

**Date:** July 2024

**Location:** Okanagan

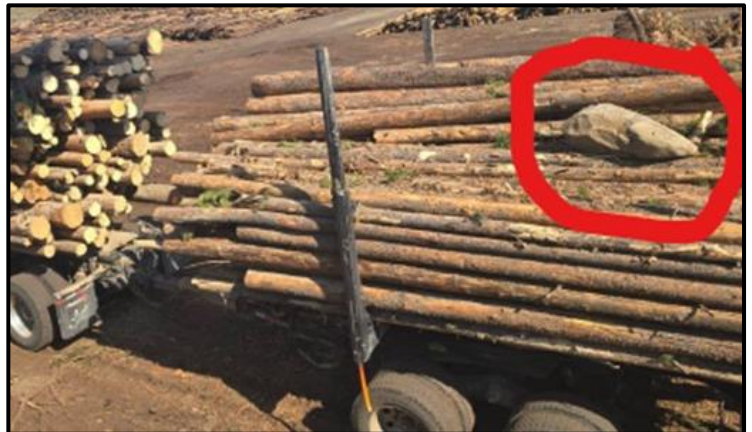
**Details:** During unloading at a mill, a boulder was discovered inside a bundle of logs being removed from the truck. It went unnoticed during the loading process, as the loader operator grabbed the bundle with the rock hidden from view on the back side.

The truck ended up at the mill before the rock was noticed by log yard staff while unloading the logs. The truck driver had previously walked around his truck and inspected the load, but the rock was not visible from his view point.

There was minimal potential for the rock to fall off the load on the trip from the block to the mill (since it was bundled inside the load), but there was more severe potential for damage to the truck / trailer, loading / unloading equipment, or workers involved in loading / unloading aspects.

- While this was one rock on one load, it demonstrates the level of care and attention that is needed with all loads at the cut block.
- Loader operator's visual inspection of the load is critical as the truck driver cannot see what is on top of or inside of the load.
- Loader operators should rotate the grapple to inspect both sides of each bundle.
- Include rotating grapple in safe work procedures when a foreign object is suspected to be in grapple.
