MANUFACTURING SAFETY ALERT

Elevated Work Platform (EWP)

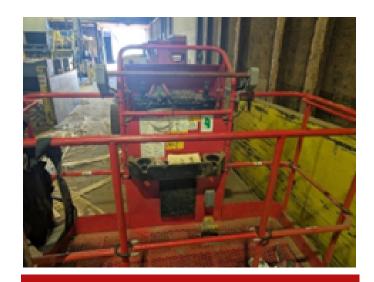
While operating the platform, the basket was positioned very close to a rafter. The AWP Operator inadvertently moved the basket toward the rafter instead of away, pinching the cleanup worker's left hand between the outside railing of the basket and the rafter.

The employee sustained a minor injury. However, the combination of equipment power, hand placement and structural proximity created a situation with the potential for serious harm.

- Reinforce hazard awareness among operators and passengers, emphasizing the importance of using inside handrails to prevent pinch/crush injuries.
- Provide training and and establish clear communication protocols between operators and passengers prior to equipment movement, ensuring all occupants are prepared before the equipment is activated.
- Increase hazard assessment training to improve employee risk awareness and promote safer operational practices.

Operators and passengers must be aware of hand and body positioning to avoid potential pinch points.

Operators should provide clear communication before equipment movement.
