MANUFACTURING SAFETY ALERT

Asbestos Exposure

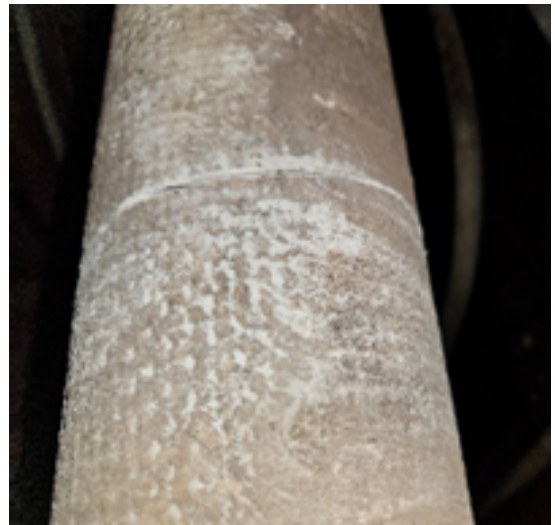
During construction, a drainpipe became dislodged and obstructed the removal of shoring supporting the roof structure. A contractor began cutting the pipe but stopped when they suspected it contained asbestos.

A review of the hazardous materials assessment confirmed the pipe material contained asbestos. WorkSafeBC and an asbestos mitigation contractor were contacted.

- **Complete hazardous materials assessments:** Ensure they are included in project safety plans and shared with all workers involved.
- **Review assessments periodically:** Do this as part of project planning, at milestones, or when the scope of work changes.
- **Supervisor response:** Supervisors should observe conditions and support pre-work hazard assessment processes when obstacles or upset conditions are reported.
