MANUFACTURING SAFETY ALERT

Electrical

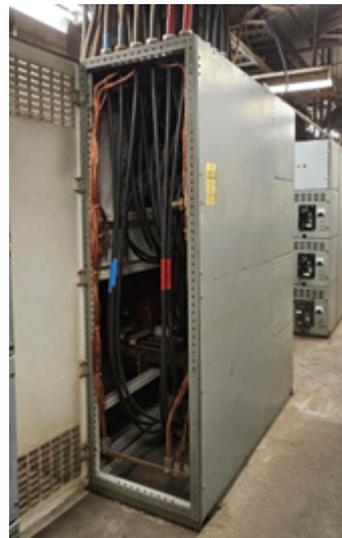
While doing rounds, an electrician discovered that the back of a power distribution center (PDC) cabinet had been left open which can put workers at risk of shock, electrocution or arc flash. An investigation found that contractors had been working in the room to install new meters and shed loads from two PDCs.

PDC cabinets and MCC buckets that are not securely closed and latched put workers at risk of shock, electrocution or arc flash.

- Review the full scope of work prior to the work starting.
- Complete checklists and verification once work is finished.
- Ensure PDC cabinets and MCC buckets are securely closed and latched.
- Have a second set of eyes verify completion when finished.
