SAFETY ALERT

Light Truck and Bulldozer Collide as Machine Backs Up

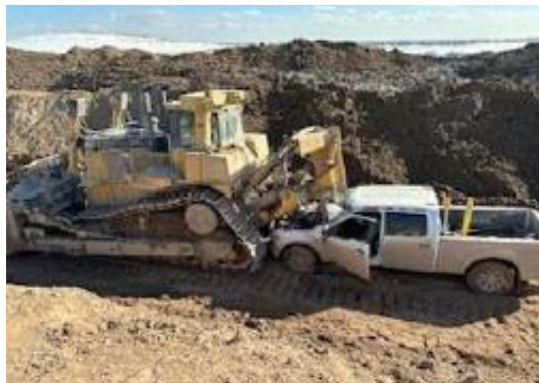
A pickup truck entered an active work area where a bulldozer was back blading in a narrow corridor. The pickup driver hailed the machine operator by radio and although no response was received, the truck continued to approach. The bulldozer reversed, causing major damage to the pickup.

The truck's driver successfully exited the vehicle and signaled the machine operator to stop. There were no injuries.

50/10 rule of approach:

- 50/ This means radio contact and acknowledgement must be established with a heavy equipment operator at a distance of 50 metres from the working equipment. Only then can the worker/vehicle approach further.
- 10/ Upon a worker/vehicle reaching the 10 metre perimeter from the working equipment, the heavy equipment operator must fully stop and ground all implements. Only then can the worker/ vehicle further approach.
