MANUFACTURING SAFETY ALERT

Contractor/Fall from Height

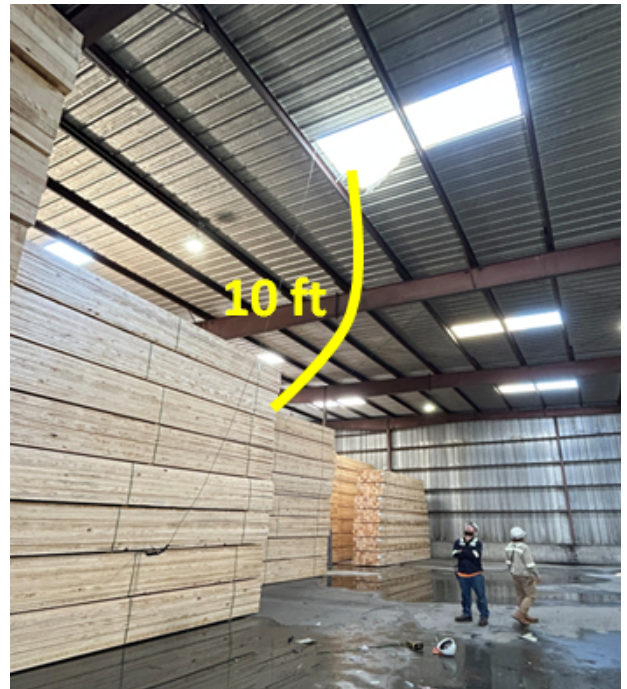
A team of contractors was working on the roof of a shed, removing skylights and replacing them with tin panels. While reaching forward to grab pieces of skylight, one of the contractors lost his footing and fell through the opening.

The contractor fell about 10 feet before his self-retracting lifeline (SRL) engaged, causing him to swing into nearby packs of lumber. The other contractors on the roof were able to manually lower him to the ground and called emergency services. The contractor had hit his head, bit his tongue, and sustained some abdominal swelling. He was airlifted for medical treatment and kept overnight for observation.

- Immediately conduct an investigation to confirm whether the contractor was using a fall restraint system instead of a fall arrest system
- Have a discussion with the team and contractors about using the correct fall protection system and following the proper hierarchy of controls when planning work at heights.

Revise current employee and contractor training programs to include using the proper hierarchy of controls to determine the correct fall protection for the job at hand.
