# MANUFACTURING SAFETY ALERT

### **Lock out Violation - Hairline Fracture of the Fingertip**

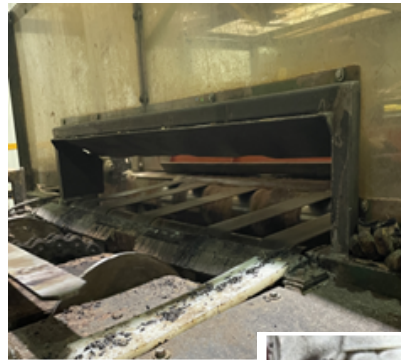
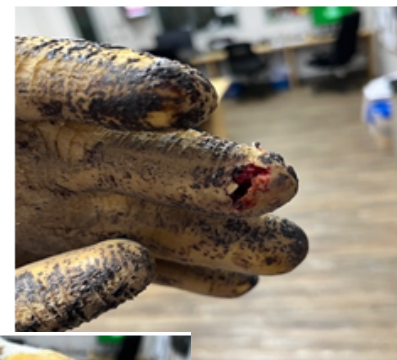
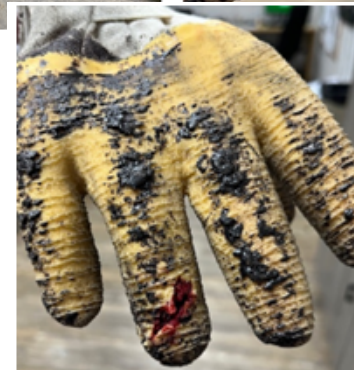
The incident occurred when the operator reached into the infeed opening of the Flying Saw - a designated lockout area - to clear debris. Unexpectedly, the clamp activated and came down on their finger while their hand was inside.

- Always follow your company's lockout policy.
- Hold stand-down meetings and toolbox safety meetings with all crews to reinforce safe work practices.
- Discuss installing curtain lights that will automatically stop the line when it detects any objects larger than a panel or typical debris entering the dust containment box.
