MANUFACTURING SAFETY ALERT

Near Miss - 600v Plug Ark Flash (SIFp)

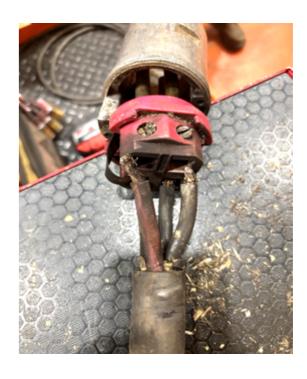
The root cause of the incident was determined to be a loose connection inside the 600v plug which led an internal failure and the arc flash.

The plug was only being held together by the strain relief. The loose connection wasn't visible in the pre-use inspection.

- Repair the damaged cable and conduct an inventory of other high-voltage equipment to schedule follow-up inspections.
- Review and update the critical tools inspection program to ensure electrical equipment is included - not just items like ladders, slings, mobile equipment, etc.

Audit the critical tools inspection program to ensure electrical equipment is included - not just ladders, slings, mobile equipment, etc.
