MANUFACTURING SAFETY ALERT

Near Miss / Scaffold / Mobile Equipment Pedestrian Interface (MEPI)

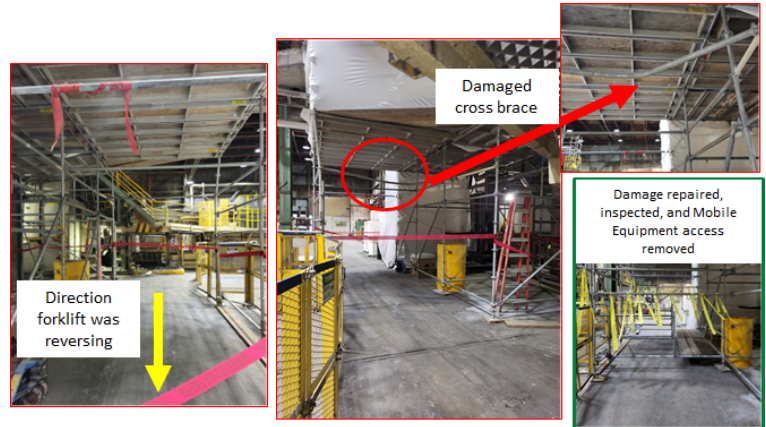
However, the pallet had not been fully lowered, leaving the forklift mast in a raised position. As the forklift backed up, the top of the mast struck the cross brace of an overhead scaffold.

Fortunately, no one was on the scaffold at the time, and no injuries occurred.

The incident revealed the scaffold placement had not been risk-assessed in relation to mobile equipment paths.

- Immediately remove the scaffold from service to further prevent risk or damage.
- Clearly mark the area by placing “**Do Not Enter**” red tape and information tags at all scaffold access points to restrict pedestrian and equipment traffic underneath.
- Notify anyone who may need to access the scaffold to avoid using it until further notice.
- Report the incident to supervisor right away to ensure proper documentation and follow-up.
- Secure the surrounding area to prevent unauthorized access while scaffold is being assessed.

Update Safe Work
Procedures (SWPs) to
include exclusion zones for
all high-risk activities (MEPI,
Working at Heights, etc.).
