MANUFACTURING SAFETY ALERT

Taylor Forklift Park Brake Circuit Fault

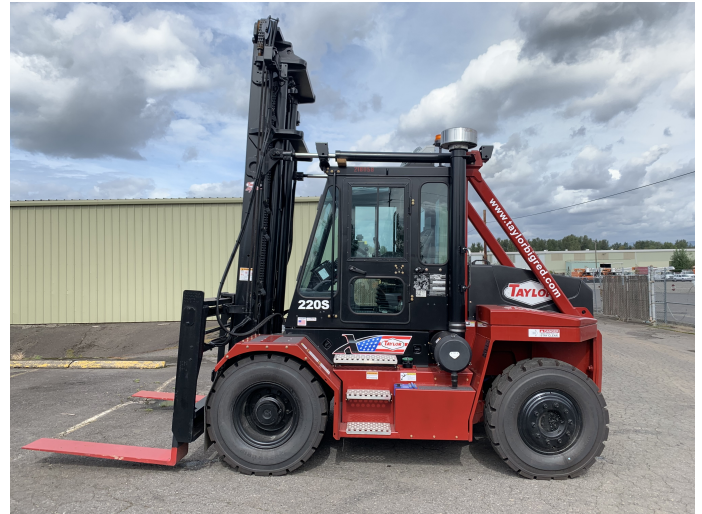
A critical fault has been identified in the park brake circuit of certain Taylor forklift models.

The current park brake switch sends an electrical signal to illuminate the dashboard indicator when the park brake is engaged.

However, in rare incidents, the park brake cartridge solenoid has failed to release hydraulic pressure, resulting in the brake caliper not fully engaging despite the indicator showing the brake as active. This poses a significant safety risk, as the forklift may move unexpectedly, potentially causing injury or damage.

- Operators: Do not rely solely on the existing dashboard indicator until the retrofit is installed. Manually verify park brake engagement (e.g., resistance to movement).
- Technicians: Ensure proper torque on fittings (25-30 ft-lbs. for #6 ORFS, 15-20 ft-lbs. for ORB) and add a diode (e.g., 1N4007) across the LED circuit to prevent switch arcing.

This fault presents a serious safety hazard. All affected forklifts should be retrofitted as soon as possible.
