# MANUFACTURING SAFETY ALERT

### **Loader Incident**

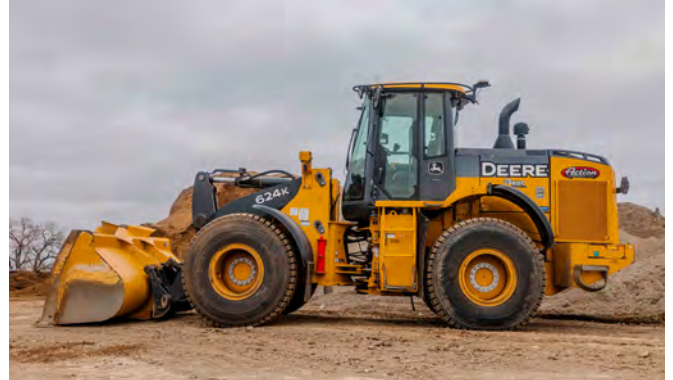
During a routine operator switchover, smoke was spotted coming from the engine bay of a 624K Loader. When the relief operator opened the compartment panel, they found smoke and glowing embers around and beneath the engine.

Operators in the area quickly responded using a fire extinguisher and hose to extinguish the embers and clear out built-up wood fiber and dust. Thanks to their fast response, they prevented a potentially serious fire.

Equipment in this area is regularly exposed to to high levels of wood fiber and dust, which can quickly build up—especially in engine compartments—and pose a significant fire risk if not cleaned regularly.

- Clean wood dust and fibre thoroughly every day and night.
- Pay extra attention to high-risk areas like engine compartments, electrical panels and hot surfaces.
- Operators should keep a close eye out during inspections and cleaning routines for accumulated wood fibre and dust.

**Regular maintenance and housekeeping are essential to reducing fire risk.**

**Consider performing engine blowdowns every four (4) hours to prevent build-up.**
