# MANUFACTURING SAFETY ALERT

### **Broken Water Trailer Coupler – Property Damage**

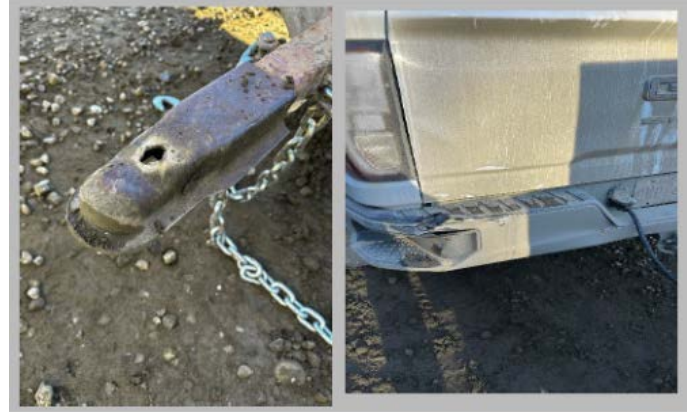
An employee was returning a water trailer to the office at the end of the season when, while driving along a road the vehicle encountered washboard and rutting.

The rough conditions caused the trailer coupler lock to break off, resulting in the trailer detaching from the hitch ball. The trailer began to fishtail and struck the back of the employee's pickup.

Fortunately, the safety chains kept the trailer connected, allowing the employee to pull over safely without further incident.

- Ensure trailer is thoroughly inspected and documented with a pre-trip inspection form
- Increased awareness on how to tighten and adjust coupler and what to look for when inspecting
- Regular check of the coupler for wear, cracks or damage
- Reduce speed on rough or washboard roads to minimize stress on trailer components

Ensure trailer is thoroughly inspected and documented with a pre-trip inspection form. Pay particular attention to couplers and other attached items
