MANUFACTURING SAFETY ALERT

Finger Laceration

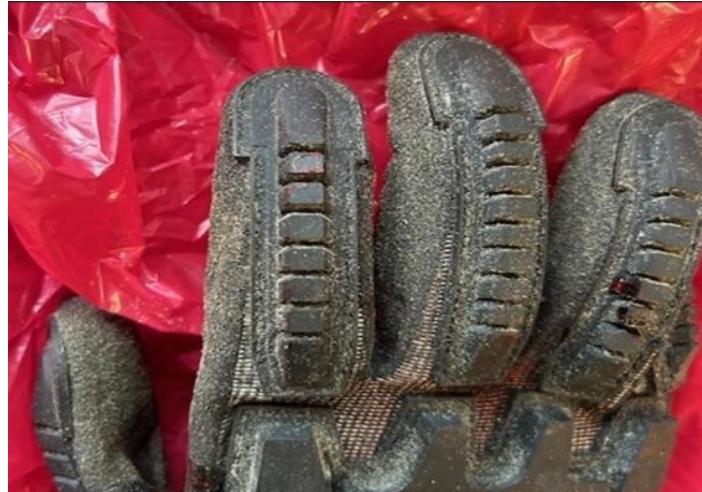
Finger Laceration Incident mp4

During a routine hazard assessment with three other millwrights, it was decided to reposition all chains back one lug in accordance with standard procedure. Following proper lockout, an apprentice attempted to realign the chains by leaning over from the side, rather than the usual head-on approach.

In doing so, the chain caught the worker's right index finger, resulting in a laceration. The employee was promptly taken to hospital, where stitches were administered. Although the apprentice returned to work shortly afterwards, it was subsequently discovered that surgery was necessary to stabilize a fracture in the finger. All required personal protective equipment was in place and remained undamaged throughout the incident.

- Crew meeting regarding hazard awareness and complacency.
- Review ergonomics and body positioning with employee(s)
- Check Trim saw PM for any issues that may cause jam ups through the trim saw zone.
- Investigate the option to use a tool similar to a hook used for hay bales. Suitable to allow for the hand to be away from the pinch point while moving chain.
