MANUFACTURING SAFETY ALERT

Injury to Right Thigh and Elbow

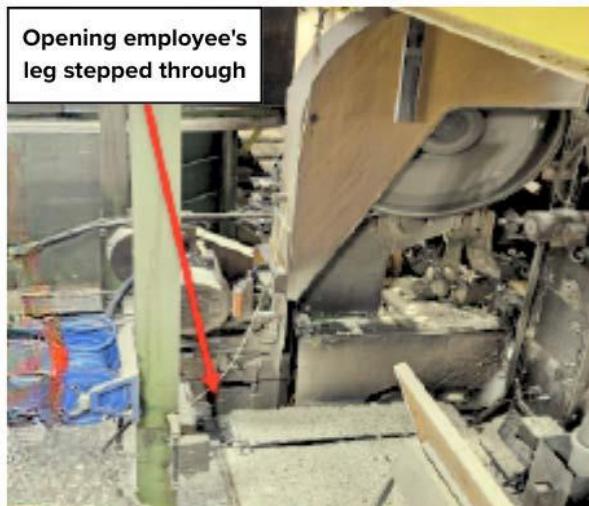
While performing routine blowdown duties in a canter bandsaw area, an employee stepped into an opening in the floor. They sustained injuries to their right thigh and elbow.

- Reduce or eliminate the floor gap in the opening to prevent similar incidents. Assess and modify the plates on the side of the bands to ensure similar hazards are also addressed.
- Review the incident with all crews to raise awareness, reinforce the importance of situational awareness, and communicate the risk of incidents caused by complacency.
- Evaluate alternative blowdown respirator mask designs that offer improved peripheral vision for enhanced safety.
