MANUFACTURING SAFETY ALERT

DESCRIPTION OF EVENT

Right Hand Fingertips

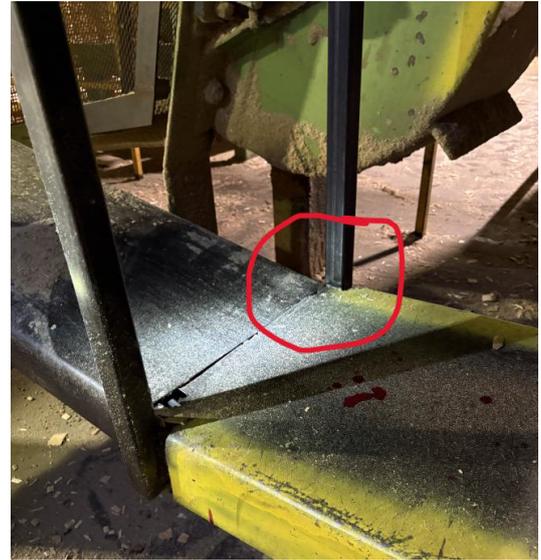
An employee was shovelling sawdust into the return conveyor when dust accumulated on the cover of a crossover conveyor. Before crossing over the conveyor, the employee attempted to wipe the dust from the cover by hand.

While doing so, the employee’s right-hand glove and fingers got caught between the box-link chain and a hole in the conveyor cover. As a result, the ring fingertip sustained an injury, the middle fingertip suffered a minor tissue tear and the small fingertip was bruised.

- Communicate with all crews to ensure tools are used for cleaning rather than hands
- Audit safeguards to confirm they effectively protect workers from contact with moving parts
- Assess the site to identify additional pinch points or guarding deficiencies and prioritize repairs
- Review the safety inspection process
- Investigate the source of the waste material and identify methods to improve containment in this area
