MANUFACTURING SAFETY ALERT

Baghouse - Falling Objects

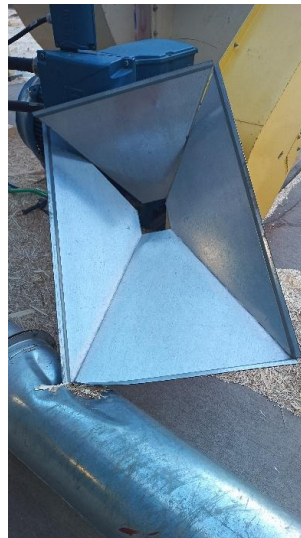
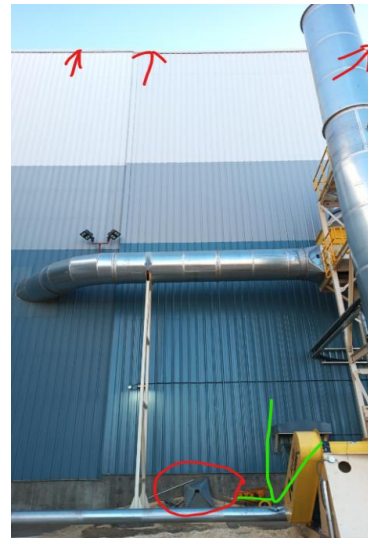
During a routine inspection at a baghouse, a tin flange was found on the ground.

The flange had fallen about 80 ft from the mill roof and punctured the baghouse’s pneumatic piping.

A preliminary investigation suggested the flange may have been left unsecured on the roof and was blown off by high winds.

- When working at heights, make sure all tools and materials are secured and never place objects near edges.
- Conduct routine inspections of work areas to maintain good housekeeping.
- Clearly communicate to all workers and contractors that clean-up should occur throughout the work period, not just at the end of the day.
