MANUFACTURING SAFETY ALERT

Cranes/Rigging

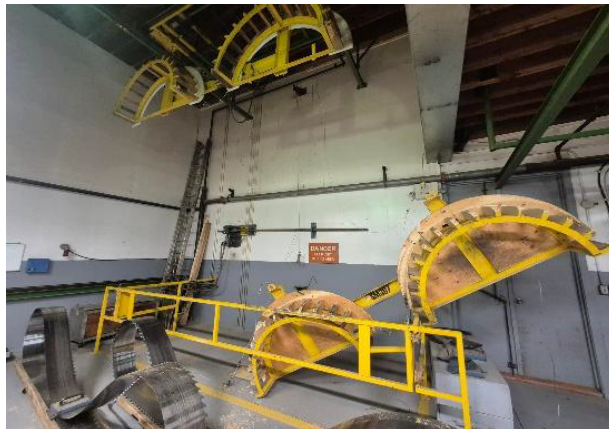
While raising the east twin band hoist, a supporting cable failed, causing the empty cradle to swing out of control and fall to the floor.

The hoist was locked out and an inspection was ordered. Preliminary findings show the cable on the south side had slipped off the drum and wrapped around the shaft during an earlier operation. This may have stretched and weakened the north cable.

- Ensure hoists are tagged out and inspected any time they experience a shock load.
- Add a quarterly inspection by maintenance staff to identify and correct any deficiencies immediately.
- Confirm the hoist is appropriately rated for the loads it is expected to lift.
- Review storage practices to ensure equipment is not stored in a way that creates a hazard if it fails.

Ensure hoists are tagged out and inspected whenever they experience a shock load during use.
