# MANUFACTURING SAFETY ALERT

### **Near Miss – Crane / Rigging**

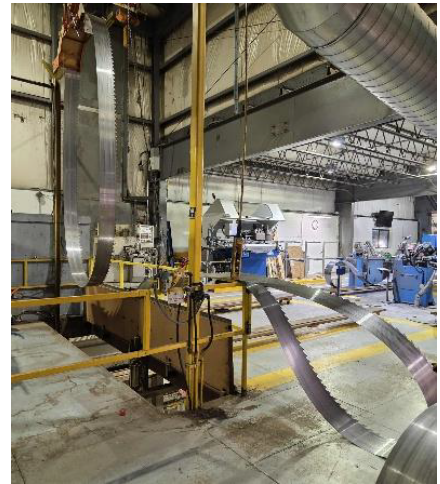
During clean-up activities, a bandsaw was struck when pneumatically activated hatch unexpectedly opened when the system was energized due to the operating valve being open position.

The impact knocked the bandsaw off its cradle which resulted in a near miss that had potential for serious injury.

- Verify that a secure holding mechanism is in place to prevent bandsaws from being unintentionally dislodged from their cradle.
- Ensure all control valves are clearly marked to show their position (for example, open or closed). In this case, the air valve labelling needed improvement so it was clear the valve was in the off position before the system was energized.
- Review storage practices to ensure bandsaws are not placed in front of access hatches or in the direct path of moving components.

It is critical to ensure restraint systems are properly in place and air valves are clearly marked to prevent equipment from becoming a struck-by hazard.
