# MANUFACTURING SAFETY ALERT

### **Paper Roll - Falling Objects**

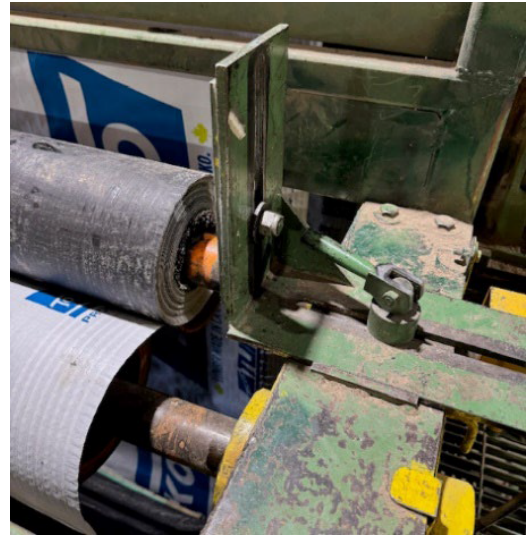
During the evening shift, a paper roll dropped unexpectedly to ground level after it came loose from its locking mechanism.

An inspection determined that one side of the locking mechanism had malfunctioned, leaving one end of the roll unsecured. The roll became misaligned, it eventually slipped through the feed works when its diameter reached about 1½ inches.

- Use pre-shift checklists to identify equipment hazards that can be corrected before starting work.
- Repair any equipment that creates a hazardous situation or put a control in place to manage the risk.

If hazards or deficiencies are reported, ensure they are repaired or locked-out and addressed before beginning work.
