# MANUFACTURING SAFETY ALERT

### **Near Miss- Lockout Save**

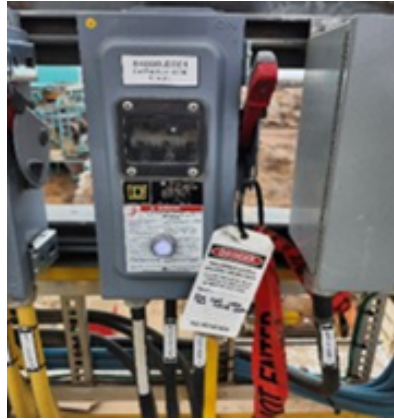
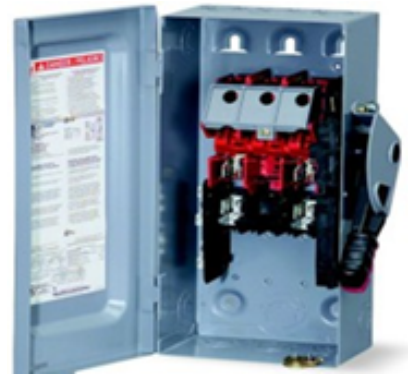
During the test fire, the fines reject conveyor started unexpectedly, even though the local disconnects were in the down position and locked out. An investigation found that the knives in the local disconnect were sticking.

- Replace the local disconnect for the fines reject conveyor at the silo.
- Reinforce the importance of maintaining visual verification when test firing equipment.
