SAFETY ALERT

Flagging tape causes helicopter crash

Location: Australia (May 2025)

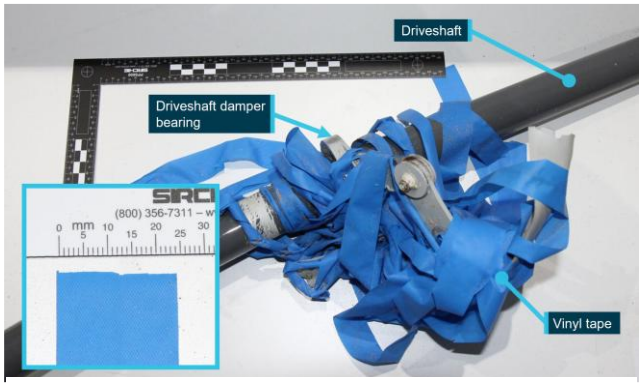
Details: During a sightseeing flight in a Robinson R44 Raven II helicopter, a 17-metre length of blue flagging tape somehow became entangled in the helicopter's main rotor swash plate, as well as the tail rotor driveshaft bearing.

Blue vinyl survey tape, wrapped around the tail rotor driveshaft and damper bearing
