## Windfall slides off rock bluff, crushing faller

Number: 2005137160100

Core activity: Manual tree falling and bucking

Date of incident: April 2005

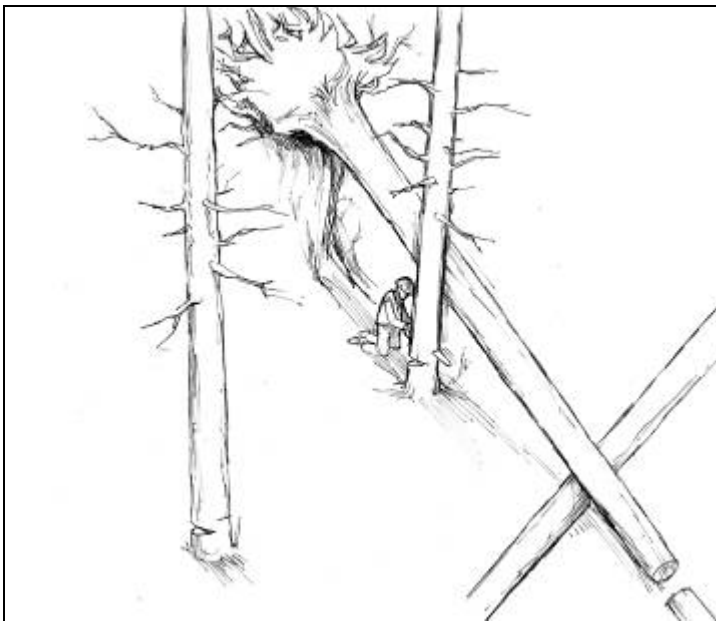
A group of four fallers were working in a forestry cut block. Each faller was working independently in his own quarter. The faller involved in the incident was attempting to fall two hemlock trees at the base of a rock bluff by using the second tree to push the first. To make the cut on the second tree, he placed himself between the standing tree and a wind-fallen tree's root wad located on a rock bluff behind him. As he began the cut, the windfall slid forward off the rock bluff. The faller was fatally crushed between the root wad and the standing tree.

The first aid attendant arrived but no pulse could be found. The windfall was cut and the root wad slung away by helicopter to allow access to the faller. The photo shows the scene after the incident.

There was another option. The first tree could have been felled in the opposite direction so that it fell across the windfall that was in contact with the second tree. This may have eliminated any potential hazard from the windfall.
