HEALTH & SAFETY ALERT

Steel Shrapnel Injures Worker When Repairing Tracks

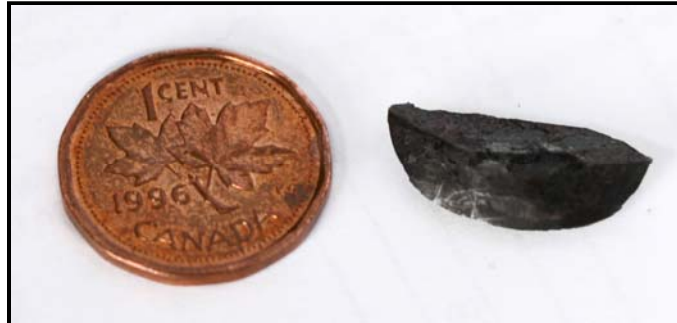
This piece of steel shrapnel hit a worker in the upper thigh, narrowly missing the femoral artery, resulting in hospitalization and surgery to repair the damage and remove the shrapnel.

The worker was replacing a track link on an excavator and used a sledge hammer to hit the pin. A shard chipped off the pin shown in the picture on the right. When hardened steel is struck with another steel tool there is always a potential for the steel to shatter. Once a piece of steel shatters the result is left to chance. The steel fragments are like bullets and result in potentially fatal injuries similar to gunshot wounds.

To avoid steel on steel hammering:

- ❑ Use a different tool (portable hydraulic track press)
- ❑ Use a softer sledge (copper, brass, composite materials)
- ❑ Use a drift¹ made of a softer metal between the pieces of steel
- ❑ Grind any splayed areas of chisels, wedges, etc.
- ❑ Discard pins, etc that show signs of previous chipping – this may indicate poor steel quality

Always eye protection, gloves & long sleeves
