## 6.1 Quad Unloading Upset - Backgrounder

**Date of Occurrence:** Thursday, June 30, 2022      **Time of incident:** 1:30 pm

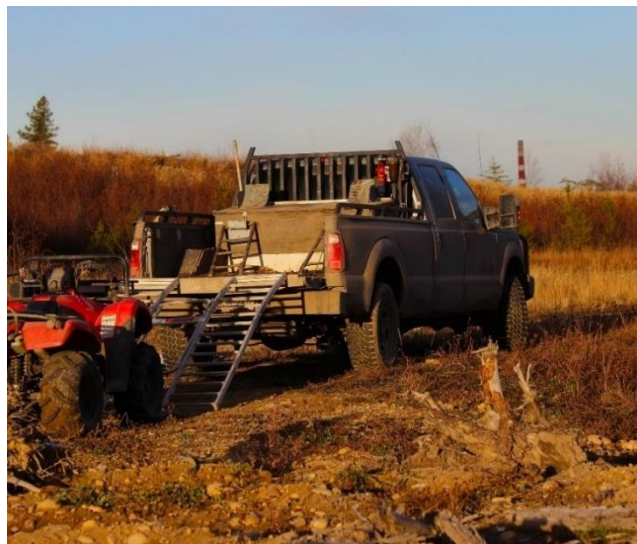
There was a dry box in the back of the Gabriel’s short box pickup that allowed the front tires of the quad to ride up in order to

fit the ATV into the 6.75' truck box for transport. The quad was usually moved by trailer or on a larger truck with a flat deck, but Gabriel had transported quads this way for years and, as a supervisor, found it quicker and more convenient than using a trailer or a larger truck.

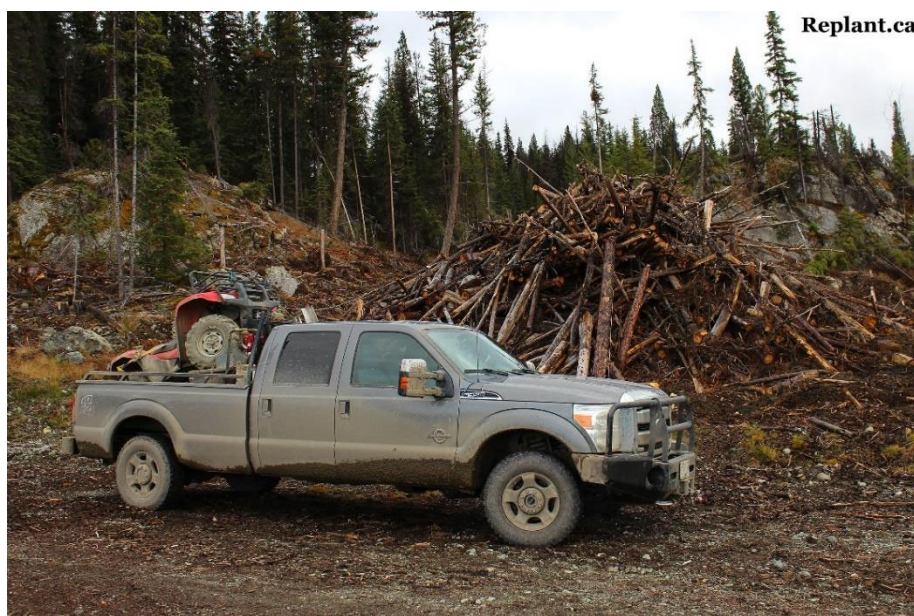
At the same moment that Gabriel was grabbing the piece of wood caught under the footrest, the right side of the quad fell off the side of the quad ramp. As the quad hit the ground, it pivoted and rolled over onto Gabriel's lower body. Gabriel tried to break the fall and get out of the way, but the quad landed in such a way that it pinned Gabriel to the ground. Gabriel experienced incredible pain and there was no way to lift the weight of the quad off their lower body, especially with an arm that seemed to be broken. The smell of leaking fuel only added to the frustration and panic Gabriel was feeling. Gabriel had a hand-held radio in their vest but was unable to get a response to several desperate calls for help.

At the emergency clinic, it was determined that Gabriel had a broken right wrist that would require a cast and a badly sprained right ankle that would need a walking boot. Gabriel was released from hospital after treatment but would end up missing 3 weeks of work.
