MANUFACTURING SAFETY ALERT

Cinch on Loaded Log Truck Came Loose Striking Vehicle.

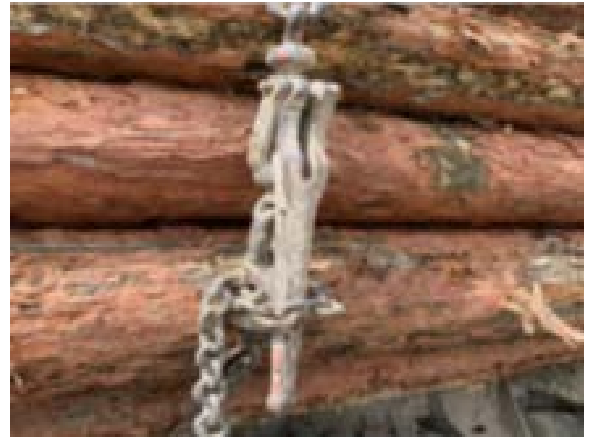
A Log truck with a full load hit a large bump on a bridge approach and cam over chain cinch became loose.

As the driver was pulling over to tighten the cinch, the cinch got caught in the tire and flew into oncoming traffic smashing the windshield and side mirror of an oncoming pick-up.

The cinches were in good shape and the driver had tightened the load about 10 km before the incident.

No cinch handle securement device was used as the welded hooks had been removed from service.

- Inspect winches and replace any that are damaged/worn.
- Ensure cinches have proper working securement devices.
- Explore the use of new cinch designs that are available (e.g. Inwood cinch) that have hooks cast into the handle.
- Increase the frequency of wrapper checks.

Damaged tools or equipment that are missing safety devices should be taken out of service.
