Grapple Yarder Slides on Road Date of talk: _____

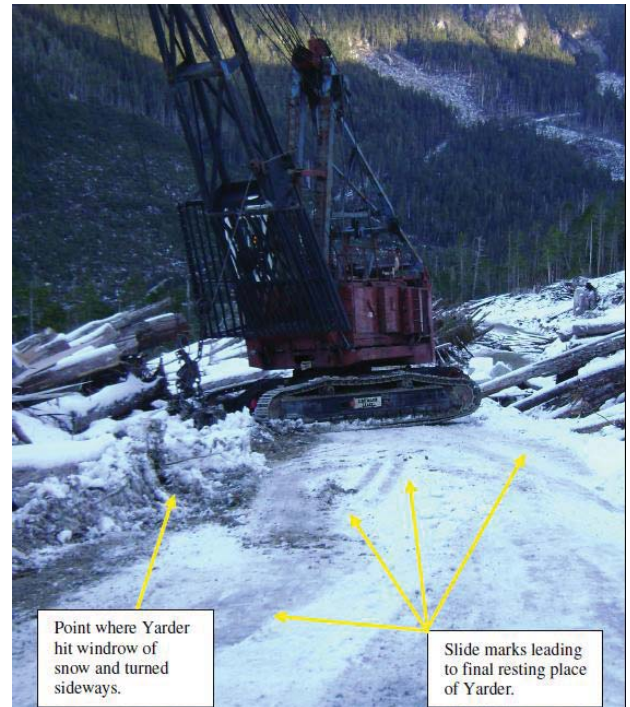
The crew was walking a Madill 044 Grapple Yarder down the road to get off a hill. The 044 was walked 500m down hill and around a switchback with no problems. As it broke over another hill,(15% grade) it slid 39 ft. The crew stopped and reassessed the situation and came to the conclusion that it would be OK to carry on. The 044 continued for 6 ft before it started to slide again, 40 ft towards the outside of the road and hit a windrow of snow and turned sideways; then continued to slide 51 more feet before coming to a stop sideways, half on the road and half in the windrow of snow.*

Frozen road.

Inadequate assessment of risk.

Point where Yarder hit windrow of snow and turned sideways.

Slide marks leading to final resting place of Yarder.

Ensure the risk assessment for similar activities adequately addresses the situation.

Ensure there is a clear expectation that the supervisor is to be contacted after warning signs of a serious upset condition is encountered (in this case the initial slide of 39').
