## **Lowbed Strikes Leaning Birch**

## **Description of the Event:**

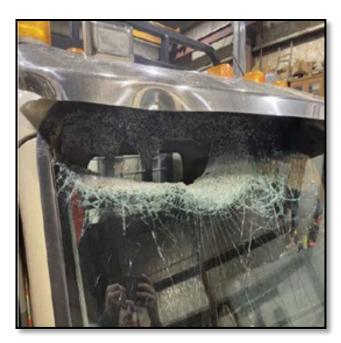
A lowbed driver travelling to a worksite at 3:00 am struck a leaning Birch tree overhanging the road, which pushed through the windshield on the passenger side and carried on through and exited the drivers' side window, narrowly missing the driver. Trucks ahead of the lowbed did not see the leaner and the leaner was not visible at the time of impact in dark conditions. It is believed that the cold temperatures (-22°C) may have caused the snow loaded Deciduous tree to snap and lean into the road after the other traffic had passed. Although this road section had been previously assessed and sanitized for overhead hazards, changing conditions can create new hazards at any time.

\*This event had a Serious Injury or Fatality potential (SIFp) – Had circumstances been slightly different, the tree could have caused serious injury to the driver.

- Danger Tree Assessments and falling on active road systems must be completed and re-assessed on an as-needed basis following significant weather changes.
- 'Jill Pokes' and leaning trees cause a serious hazard for all traffic and should be identified, communicated and removed as soon as practicable and safe to do so.
- Use radio to notify other road users of potential hazards.
