MANUFACTURING SAFETY ALERT

Log Almost Struck Employee

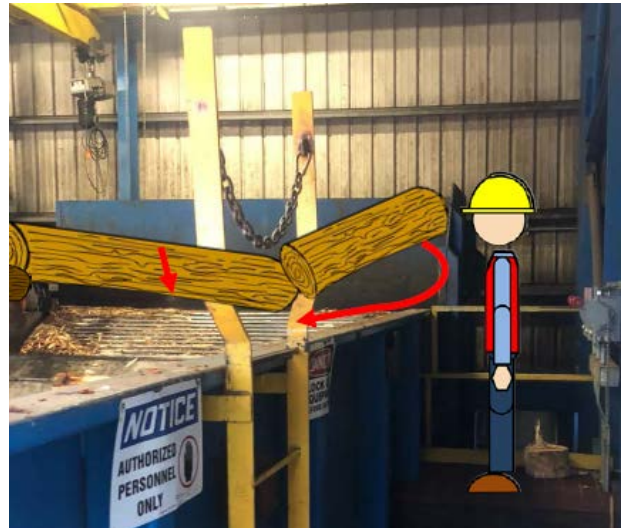
An over-length log was sent to the transfer deck. It needed to be cut to progress forward. After a pre-work assessment was performed and a lockout was completed, the employee cut the log. The out-feed conveyor kicker was used to sweep a few blocks away.

After this task was done, the supervisor then asked the merchandiser operator to run a log onto the deck. The incoming log hit half the cut log and pushed it up the wall until it fell back onto the deck.

The supervisor quickly moved out of the way and was hit by the falling log. He pushed the log away as it fell.

- Ensure the pre-work inspection includes all possible hazards that could occur from the beginning through to the end of the job.
- Maintain control of an upset at all times.

Ensure everyone is out of the bite when you start-up after an upset condition.
