DESCRIPTION OF EVENT

Charge Pushed Through Kiln Door

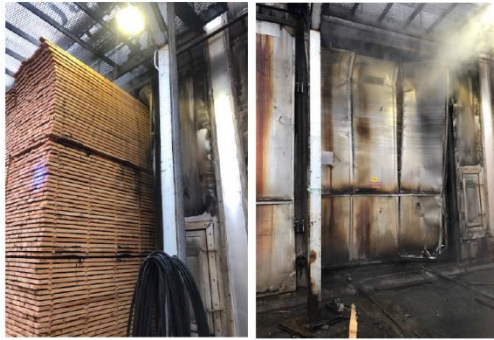
Two forklift drivers were working together to finish up building a charge. One driver proceeded to push the last carts up against the rest of the charge, felt some resistance and continued to push until he reached a predetermined spot.

The operator assumed he was hung up so he continued to push. The kiln carts were pushed through the rear kiln doors as there were 7 carts on the track instead of the usual 6.

- Before pushing the carts into the kiln verify the number of carts on the track.
- Consider performing a pre-task assessment before pushing the carts into the kiln.
