**DESCRIPTION OF EVENT****Kiln Cart Ran Over By Forklift**

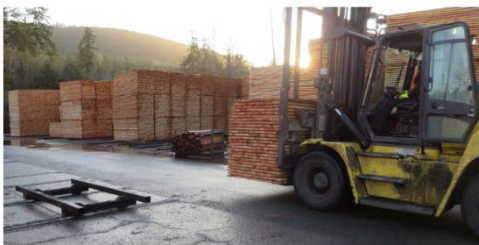
A Forklift Operator was carrying a load while traveling through the storage yard.

Their left door suddenly slammed shut due to a broken door latch. The operator over corrected and clipped and ran over a kiln cart causing extensive damage to the forklift under carriage and right side hydraulic tank.

- **Improve Visibility:**  
Add additional lighting and increase the visibility of fixed and mobile objects in storage yards.
- **Inspect and Repair:**  
Operational and safety-related mobile equipment issues are to be repaired before the forklift is put to use.
- **Immediately Report:**  
Damage events require notification to management immediately.
- **Eliminate Congestion:**  
Carts and racks should only be out while actively loading and unloading.

Review the forklift pre-use inspection process to ensure that all operational and safety related items are included in the inspection.
